DUTAIASE CANISTER PURGE VALVES

Turalast CANISTER PURGE VALVES

IMPROVES ON LIMITATIONS IN THE OE DESIGN

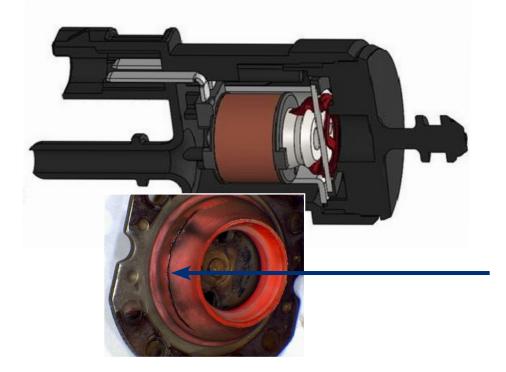
OE PROBLEM

The plunger assembly cracks, causing an EVAP system leak.

Source: GM Technical Service Bulletin 18029

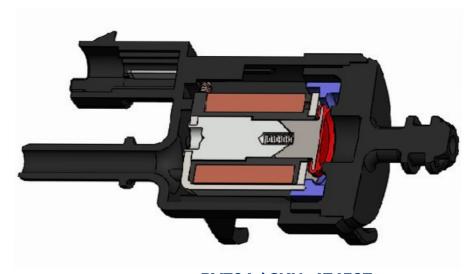
PV704 / SKU: 474527 (MADE IN THE USA)

THE DURALAST® DIFFERENCE

Improved geometry keeps the plunger in alignment, reducing wear on the seal. The result is a longer-lasting component.
